You are here: The Journey > Men and machines > Cranes Cranes

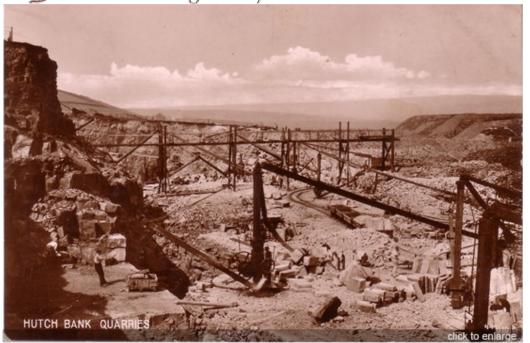
Remains of crane base in Lee Quarry

Derrick cranes were a feature of most quarries, where they were commonly used by the banker masons to help them handle large blocks of stone. In some quarries rows of these cranes were built by linking their wooden stays into a long single structure. This would save on the number of crane bases that had to be built.

Early cranes developed into the **derrick crane**. These had a jib fixed to an upright mast supported by two or three wooden stays. The stays were attached to heavy bases constructed from piles of stone, making the structure into a strong and rigid frame. The jib was suspended from the mast and the mast and jib could rotate together to swing the load from side to side. Often the cranes no longer remain, but evidence of their location is indicated by large piles of counterweight stones used to tie down the stays.

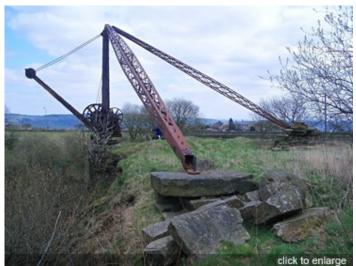
Good example of a crane at Mount Tabor, Halifax. Dismantled 2008.

At first the lifting hook was wound up and down by hand and this remained so for the masons' cranes. But from the later part of the 19th century **powered cranes** came into use in the larger quarries to lift stone from quarry pits. **Steam power** came first, followed by **compressed air** and then **electric power**. All these cranes were fixed on a platform or to stone or concrete foundations. They were often positioned above the quarry face and had to be shifted with some difficulty into a new position whenever the face advanced.
